DEPARTMENT OF TRANSPORTATION

Contract #: 04-0120F4Cty: SF/ALA Rte: 80 PM: 13.2/13.9File #: 69.28**WELDING INSPECTION REPORT****Resident Engineer:**Siegenthaler, Peter**Address:** 333 Burma Road**City:** Oakland, CA 94607**Report No:** WIR-017588**Date Inspected:** 20-Oct-2010**Project Name:** SAS Superstructure**OSM Arrival Time:** 700**Prime Contractor:** American Bridge/Fluor Enterprises, a JV**OSM Departure Time:** 1900**Contractor:** Zhenhua Port Machinery Company, Ltd (ZPMC), Changxing Island **Location:** Shanghai, China**CWI Name:** Mr.Qiu Wen.**CWI Present:** Yes No**Inspected CWI report:** Yes No N/A**Rod Oven in Use:** Yes No N/A**Electrode to specification:** Yes No N/A**Weld Procedures Followed:** Yes No N/A**Qualified Welders:** Yes No N/A**Verified Joint Fit-up:** Yes No N/A**Approved Drawings:** Yes No N/A**Approved WPS:** Yes No N/A**Delayed / Cancelled:** Yes No N/A**Bridge No:** 34-0006**Component:** Tower and Orthotropic Box Girder (OBG)**Summary of Items Observed:**

WELDING INSPECTION REPORT

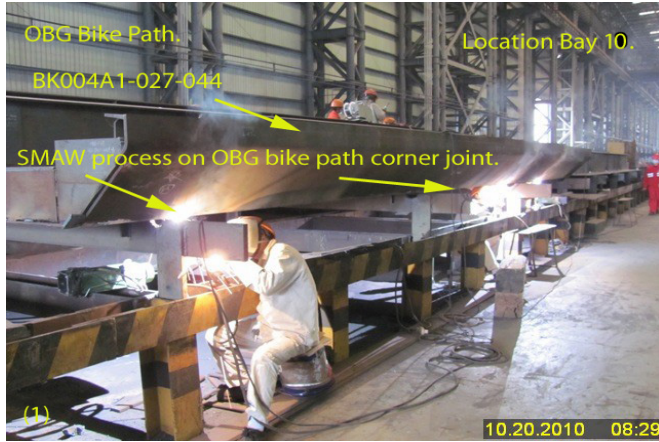
This QA Inspector observed ZPMC qualified welding personnel identified as 050363, 057258, 052493, Perform Shielded Metal Arc Welding (SMAW) on OBG Bike path side plate to deck plate. Joint identified as BK004A1-027-044. ZPMC QC Identified as Li Jun. The welding parameters as measured using QC's calibrated instrument appeared to be in general compliance with WPS-B-P-2214-B-U2. For more information see below attached picture number 1.
